Address: 41 Grove Street Sea Cliff, New York

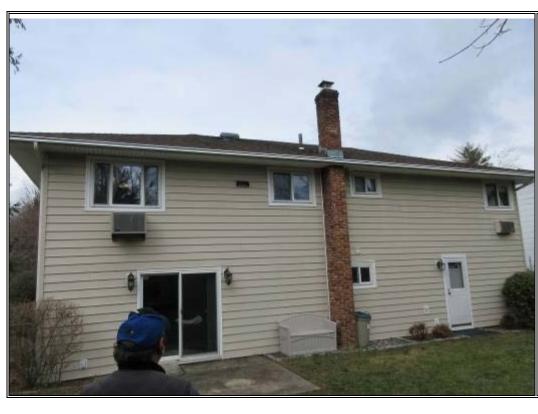
Description: Rear elevation

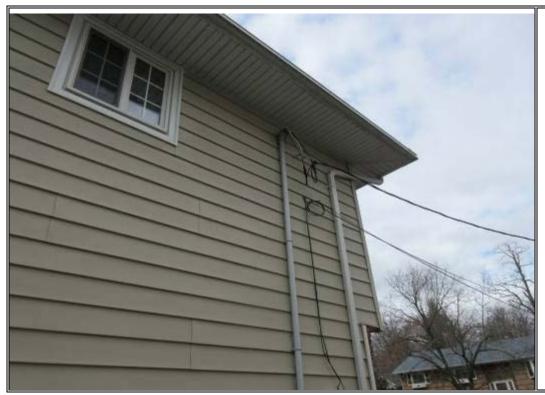
Electric service

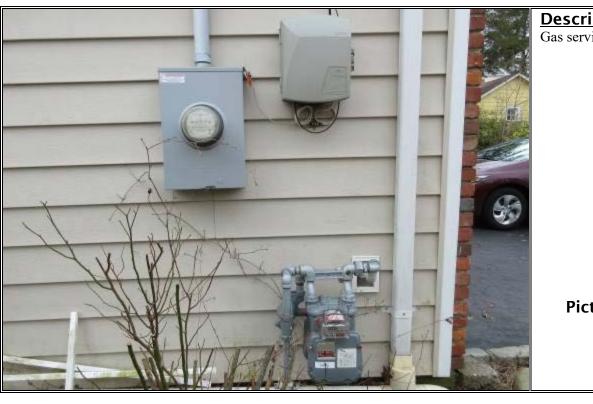
Description:Gas service

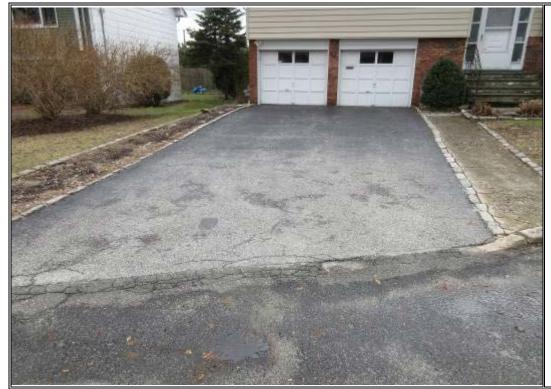
Description: Driveway

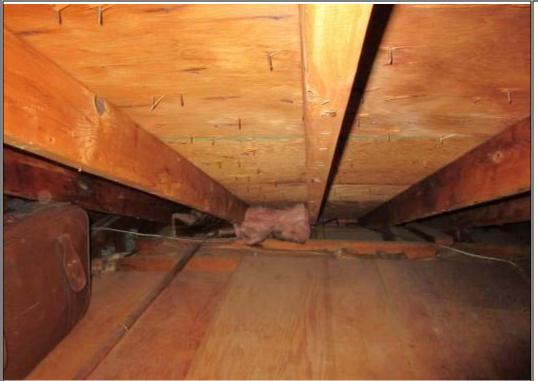
Description: Attic view 1

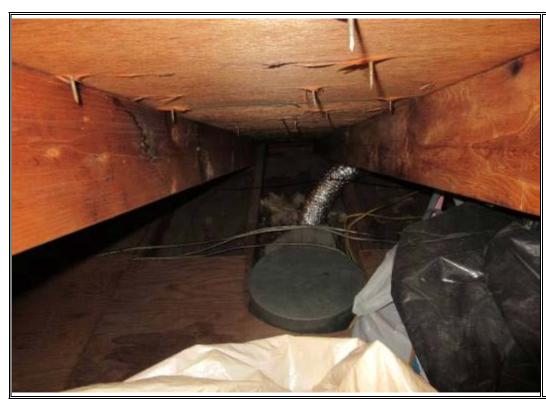
Description: Attic view 2

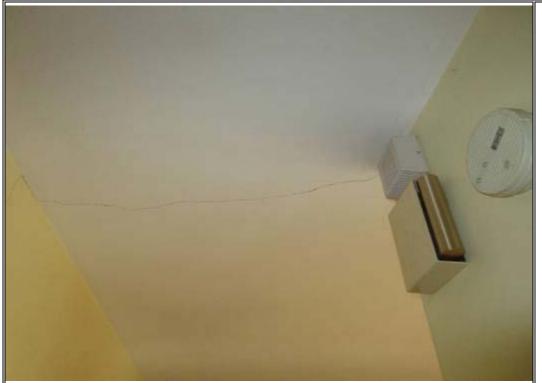
Description: Ceiling cracks

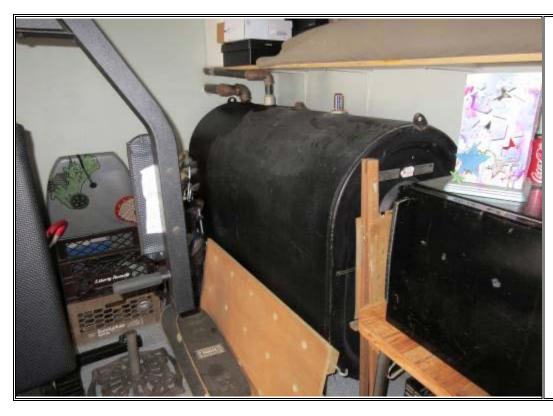
Description:
Garage fuel oil storage tank

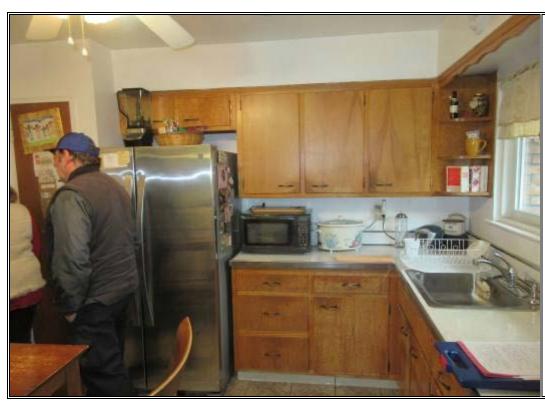
Description: Kitchen

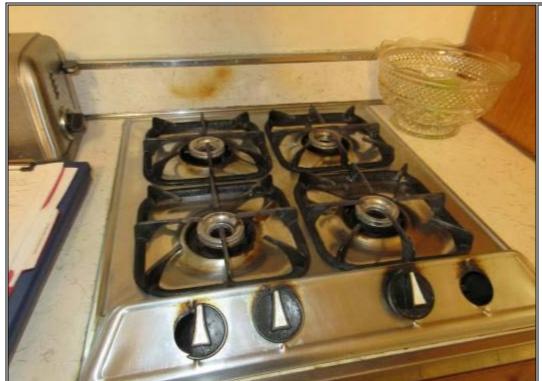
Description: Stove

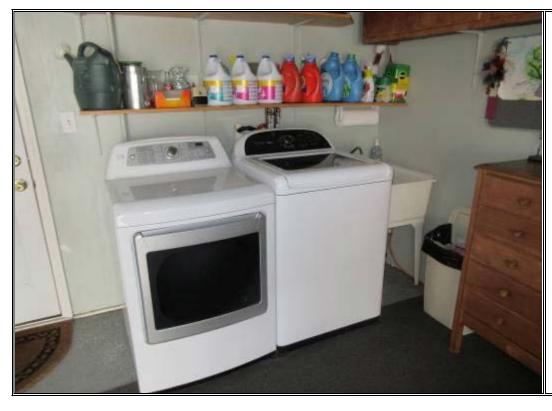
Description:Washer and dryer

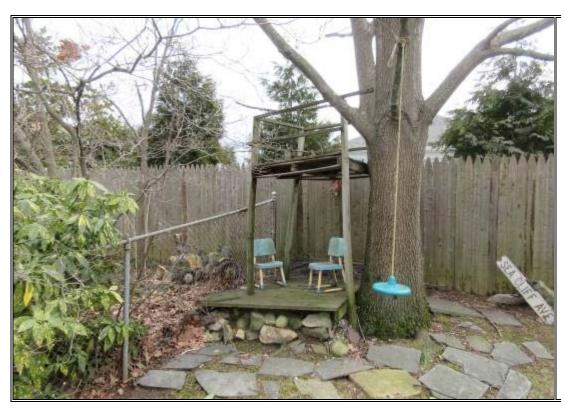
Description: Tree house

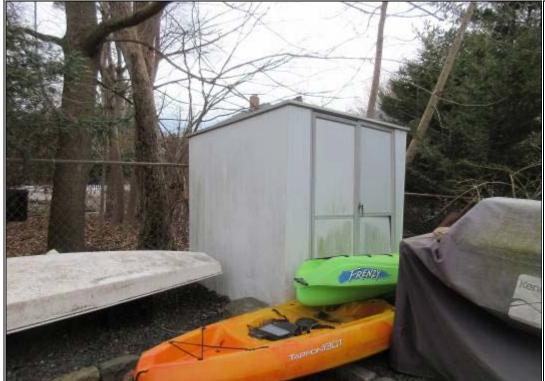
Description: Shed
